Manhole Inspection Summary

Manhole # S21C__032MH

Insp Date: **4/6/09 1:45 PM**

Location Address: **MONROE ST**

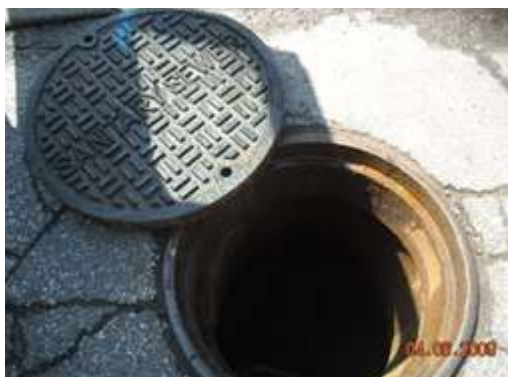
PREVIOUSLY BROKE AND REPLACED
LID WITH NEW 24" LID

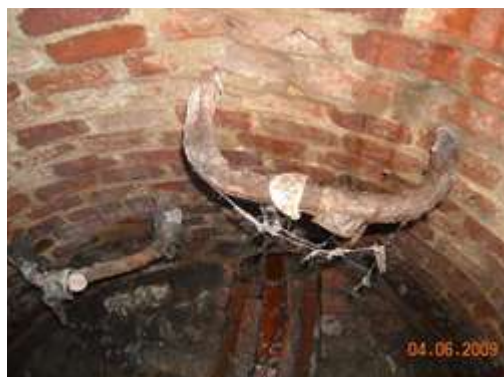
Defect 7

☒ **Evidence Of Surcharge**

Depth: **3** (ft.)

EVIDENCE OF SURCHARGE AT 3'

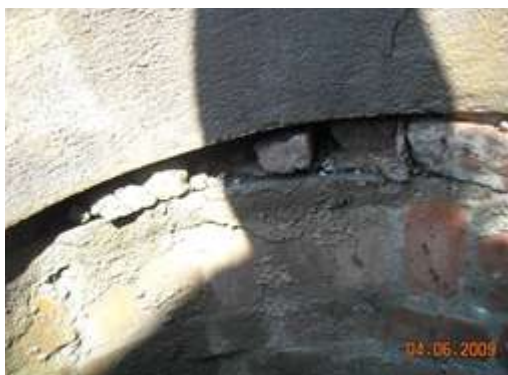
Defect 6

☒ **Deteriorated**

DETERIORATED BRICKS IN CHIMNEY

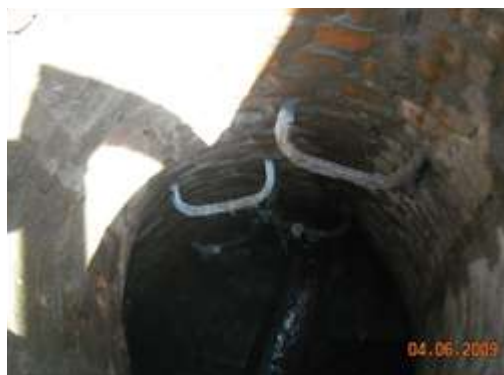
Defect 5

☒ **Corroded**

CORRODED STEPS

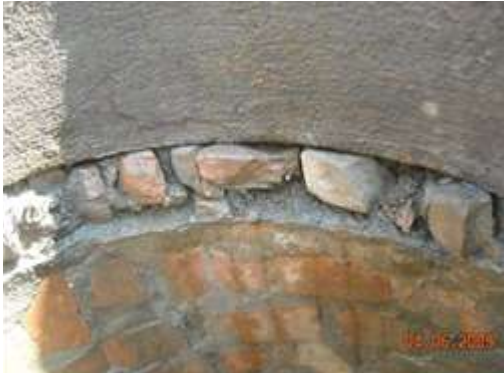
Defect 4

☒ **Loose Brick**

LOOSE BRICKS IN CHIMNEY

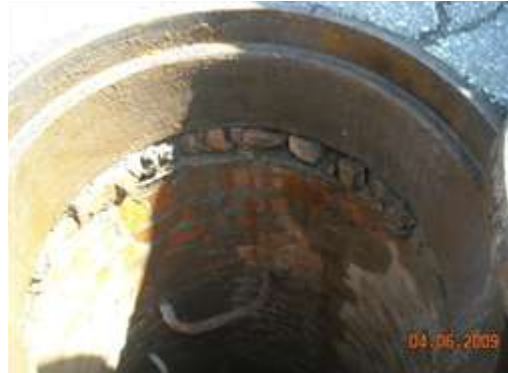
Defect 3

☒ **Leaks**

EVIDENCE FRAME LEAKS

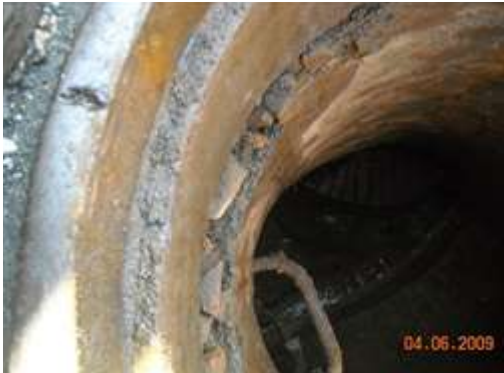
Defect 2

Offset: **1** (in.)

FRAME OFFSET 1"

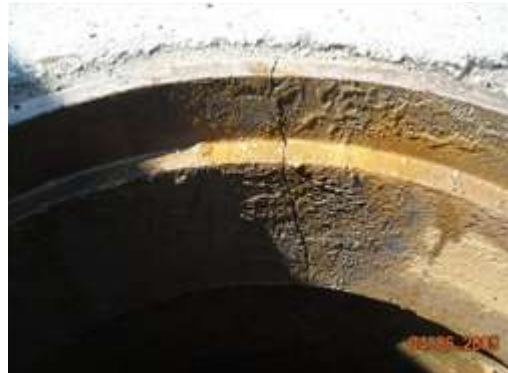
Defect 1

☒ **Cracked**

CRACKED FRAME

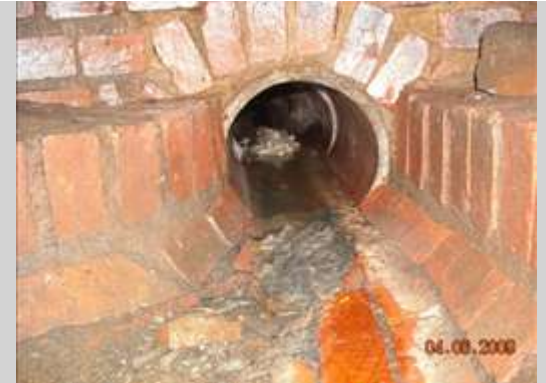
12 O'Clock Outflow

Pipe Height: **8.4** (in.) Rod and Bar (Angled)
Pipe Material: **Clay** ☐ Pipe Lined
Invert Depth: **8.09** (ft.) Flow Characteristics: **Slow**
Deposits: ☐ None ☐ **Mud** ☐ Sludge ☒ **Debris** ☐ Grease
Silt Depth: **3** (in.) Deposits Extent: **Light**
Infiltration: **None** Pipe Seal Cond: **Sound**

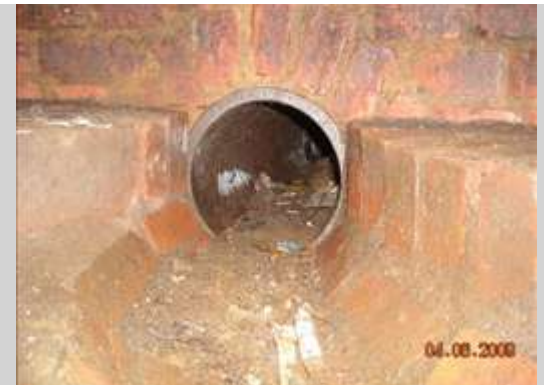
9 O'Clock Inflow

DEBRIS IN CHANNEL - LIGHT MUD

Deposits: ☐ None ☒ **Mud** ☐ Sludge ☐ Debris ☐ Grease

Silt Depth: **1** (in.) Deposits Extent: **Light**
